Non-Motorized Transport

Pedestrians Cyclists Wheelchairs

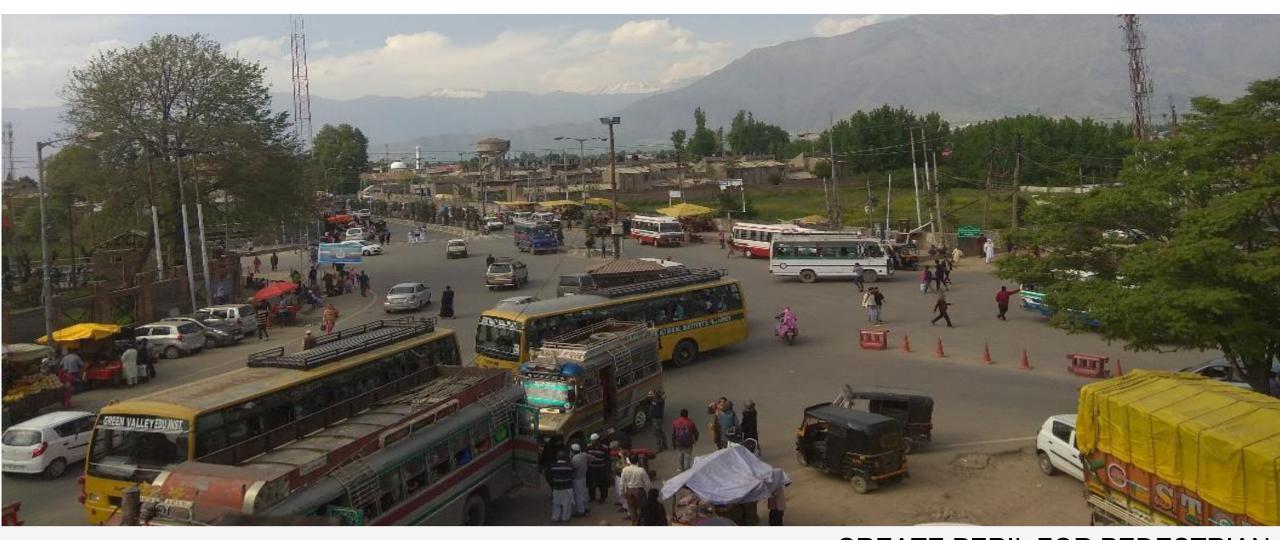
Soura Junction, Srinagar.

CREATE PERIL FOR PEDESTRIAN
REDUCE EFFECTIVE CARRYING CAPACITY OF LANES
PROVIDE PROPER PEDESTRIAN CROSSINGS
AVOID CONFLICT OF TRAFFIC AND PEDESTRIAN

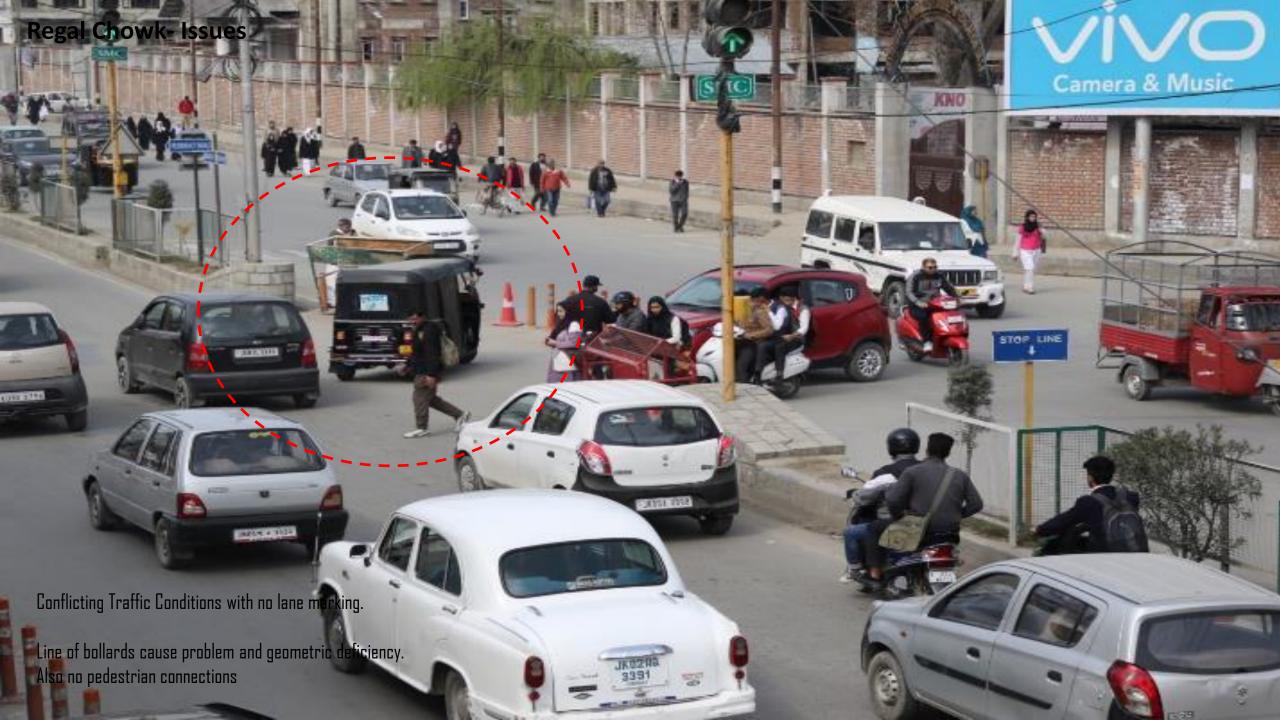
REGAL CHOWK, Srinagar

Regal Chowk- Issues

Lack of appropriate pedestrian walkway

Traffic Management is an issue

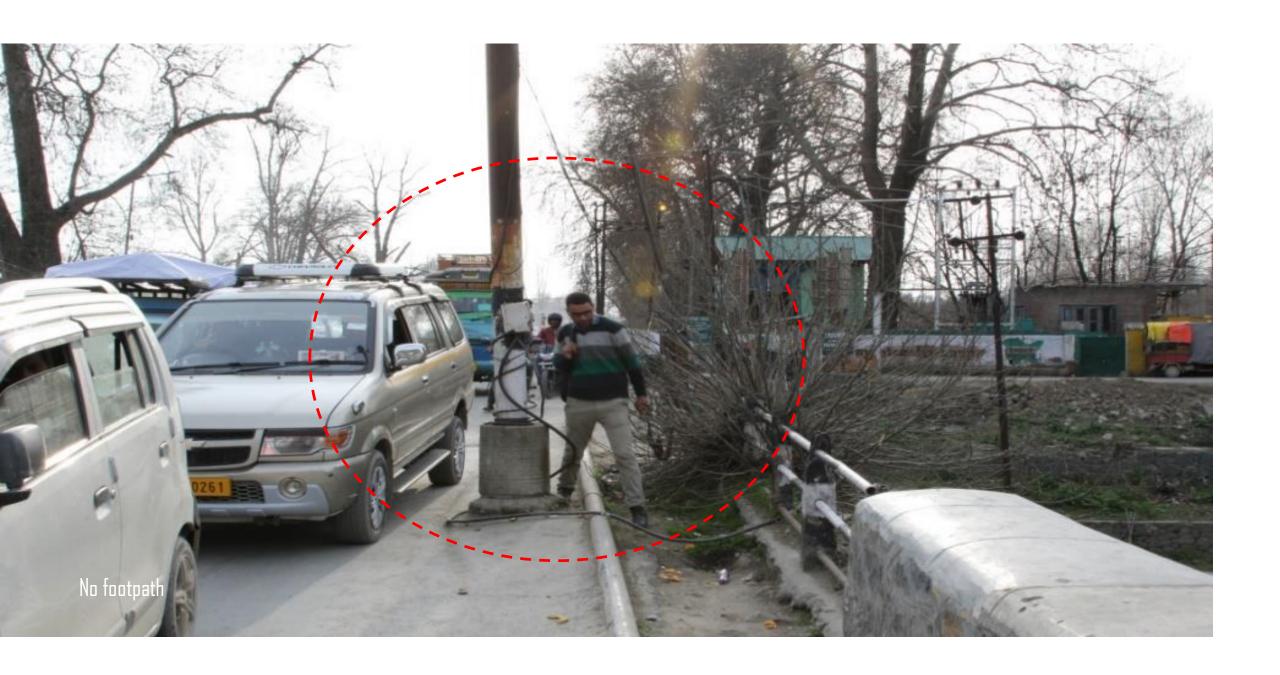
DALGATE CHOWK, Srinagar

Dal Gate Data

Before:

Traffic throughput : 22 PCU per minute

Pedestrian throughput: 18 pedestrians per minute (unsafe crossing)

Applied modifications:

Diameter of rotary: 13m Central traffic lanes: 7.5m

Traffic lane width in arms: 6m each direction
